Testing of Shelter Design and Industrial Hardening Concepts at the Mill Race Event

FINAL REPORT

Contract No. EMW-C-0611
Work Unit 1128D

SCIENTIFIC SERVICE, INC.

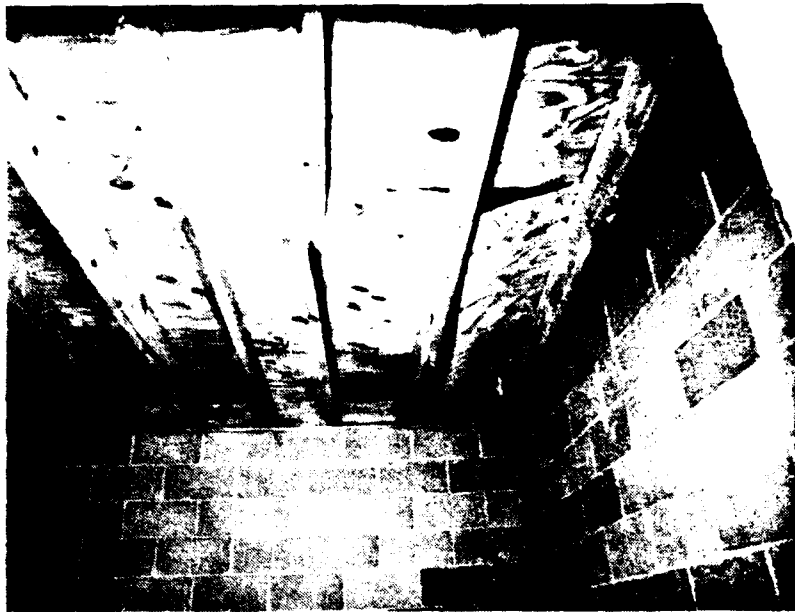
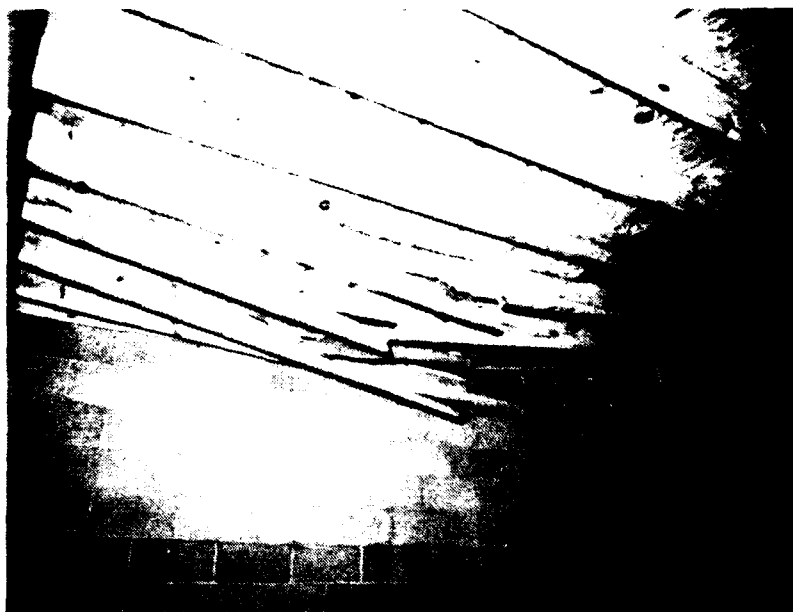
Soon after the backfilling operation was completed, it was noticed that seven of the 2-in.-by-8-in. timber joists in the unshored section of the building had failed. These failed joists were replaced prior to the test. Figure 4-10 shows the failed portion of the ceiling prior to repair.

Fig. 4-10. Pretest Joist Failures.

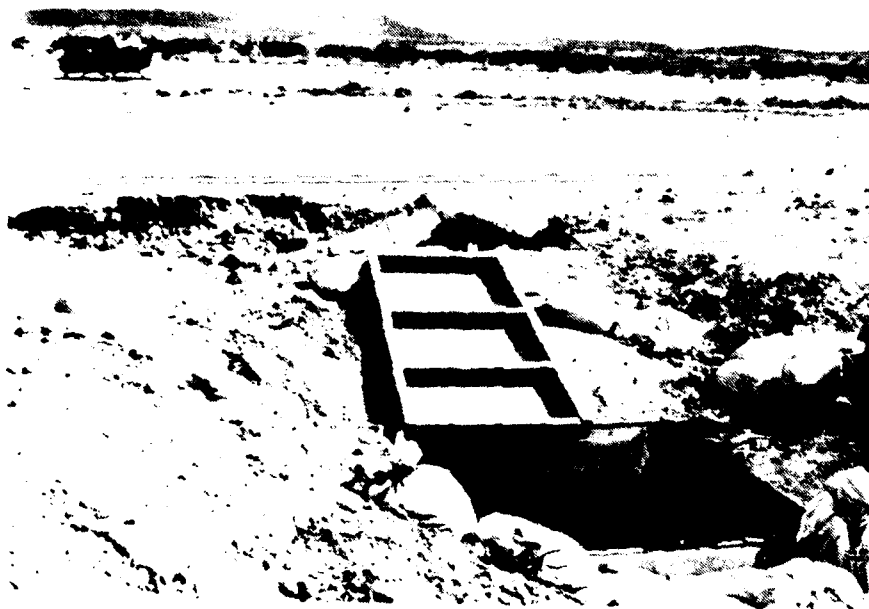
Fig. 4-14. Hatch, Posttest.

The closure over the hatch was not secured adequately to resist the positive interior pressure created by the failure of the adjacent bay. As in many of the experiments, this hatch was expedient and designed to permit ease of access immediately prior to the test. In order to perform as a viable shelter, it would be necessary to secure the hatch from the inside, as well as close off the doorway to the unshored bay.

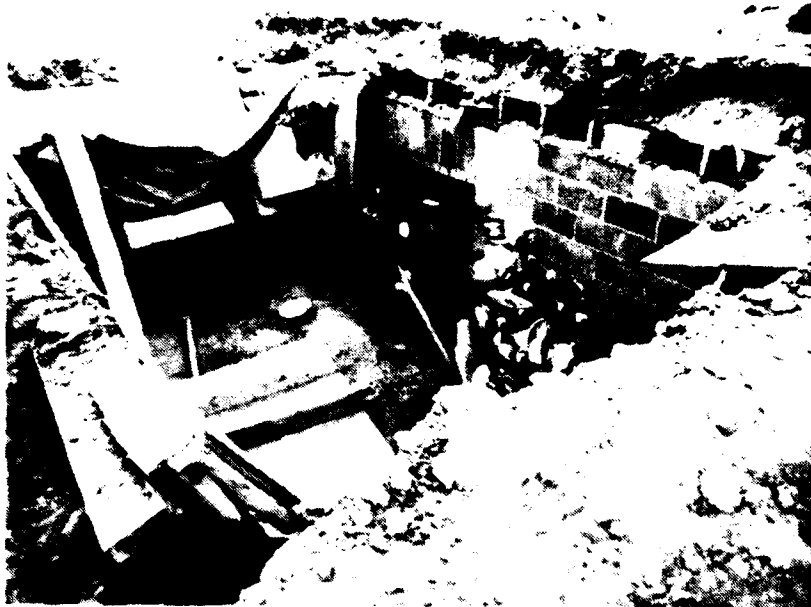
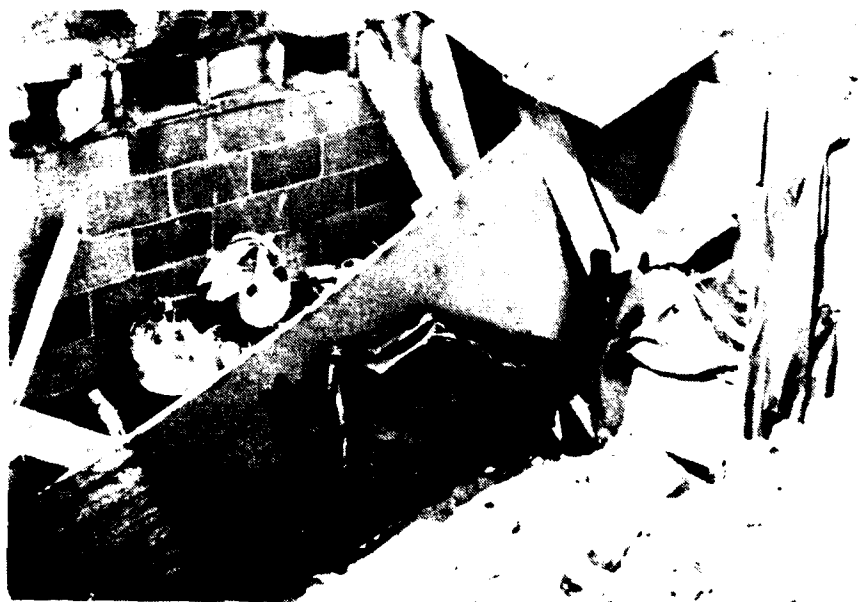
The initial observations of the building after the test indicated complete collapse of the unshored bay, and very little structural distress in the shored bay. The basement walls sustained no structural damage and no cracks were in evidence. The closure hatch, which was located in the shored bay, had been blown off, scattering both hatch section and the sandbags. Figure 4-14 shows the hatch after test. Figure 4-15 shows the failed bay looking toward the unfailed bay.

In the foreground of the lower photograph of Figure 4-15, completely covered with earth and debris, is one of the anthropomorphic dummies (18). This dummy was entirely covered to an average depth of 3.5 ft with earth and roof materials. It was found lying face down on the floor with its head near the pretest location, its feet and body displaced toward ground zero, and its legs bent forward at the knees. It had sustained multiple lacerations and extensive crushing injuries, including the breaking of both knee joints. The accelerometer reading indicated 10 g.

Fig. 4-15. Views of Failed Bay Looking Toward Unfailed Bay.

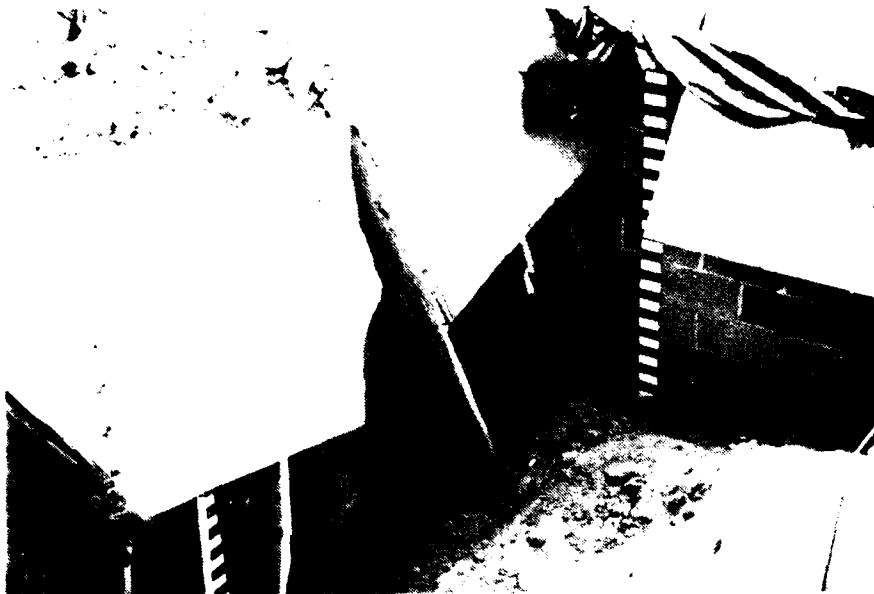
Figure 4-16 shows views of the failed bay looking down toward the exterior wall. Both of these figures show dummy No. 23. Figure 4-17 is a closeup of dummy No. 23. The location of this dummy was the same as pretest, with earth and roof materials covering both legs to an average depth of 1.5 ft. The dummy was found to have sustained two deep lacerations on the head, the chest was crushed, and both legs were broken at the knee joints. The accelerometer reading on this dummy also indicated 10 g.

Fig. 4-16. Views of Failed Bay Looking Toward Exterior Wall.

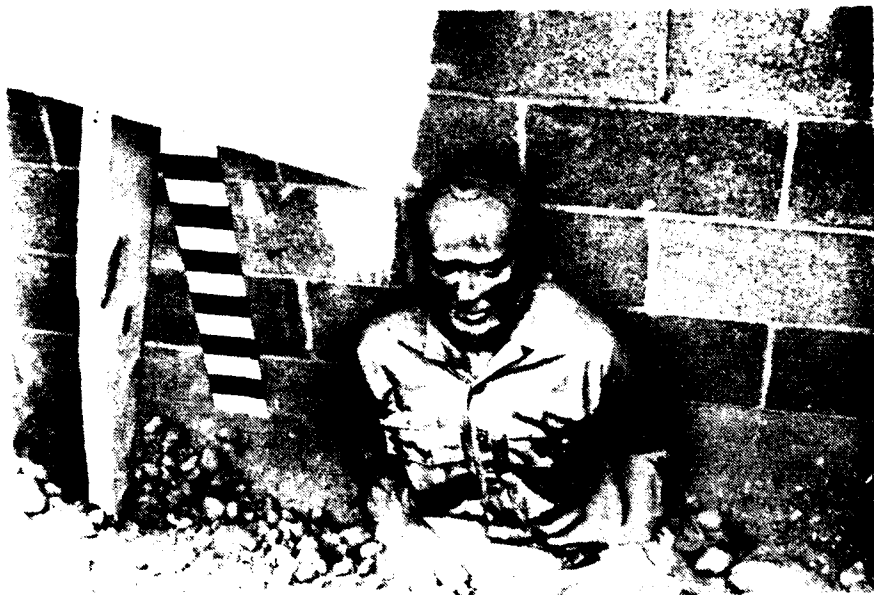
Fig. 4-17. Closeup of Anthropomorphic P. No. 23, Posttest.

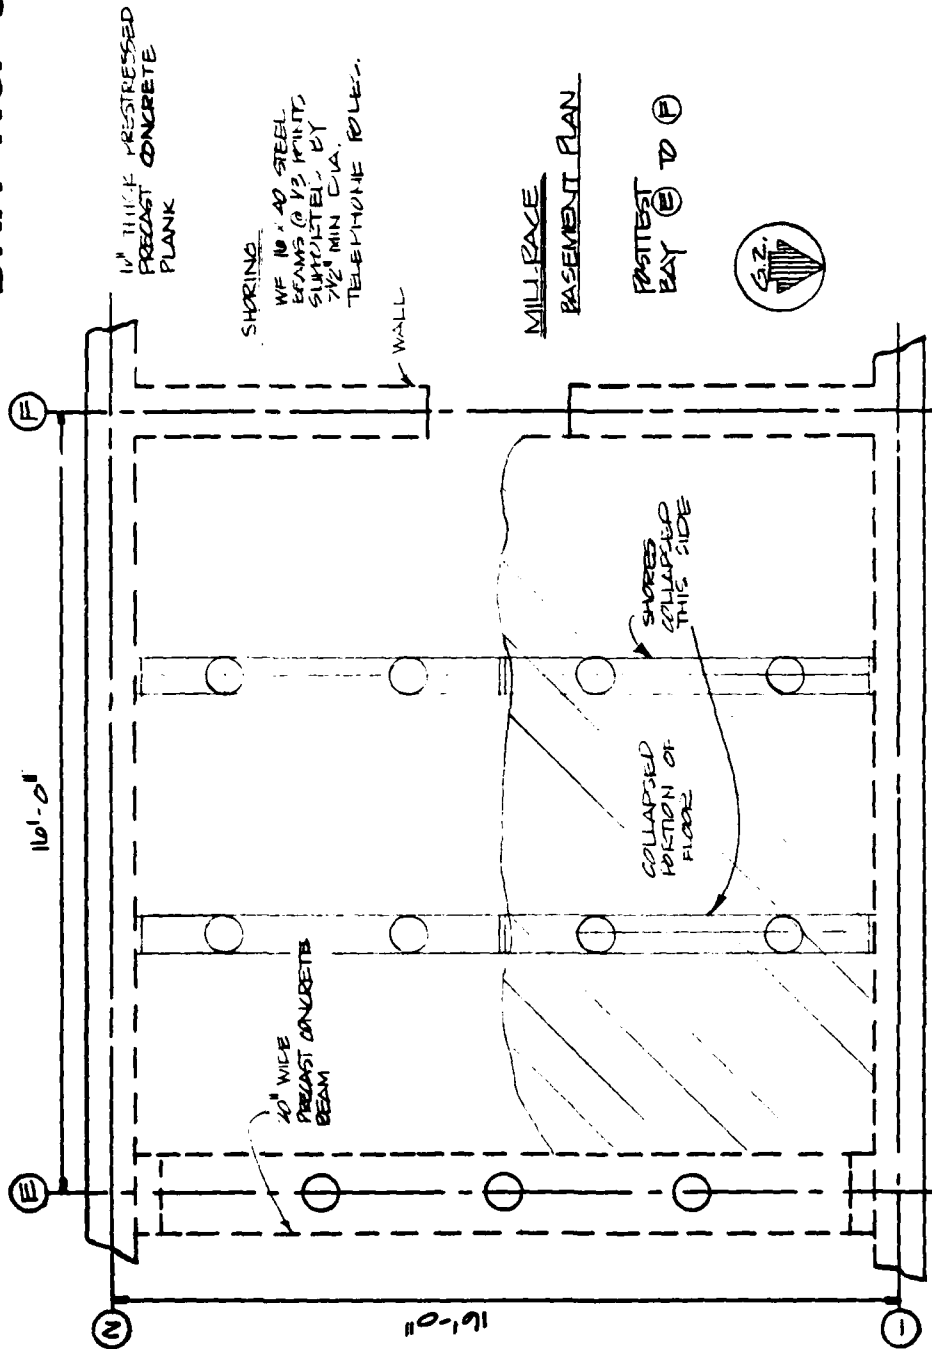
The bay from lines E to F (Figures 5-1, 5-5, and 5-19), also constructed of prestressed concrete plank, but shored at the one-third points, had approximately one-half of the floor collapse, as shown in Figure 5-37. The remainder of the planks were again badly cracked transversely at their wall/beam and shore supports, but did not collapse. Figure 5-38 shows views looking down into the collapsed portion. The precast concrete beam and supporting corbels on line E did not indicate any structural damage, and the three shores supporting it were still in place.

Fig. 5-37. Location of Shoring and Damage to Precast Plank Floor, Bay E to F, Area No. 2.

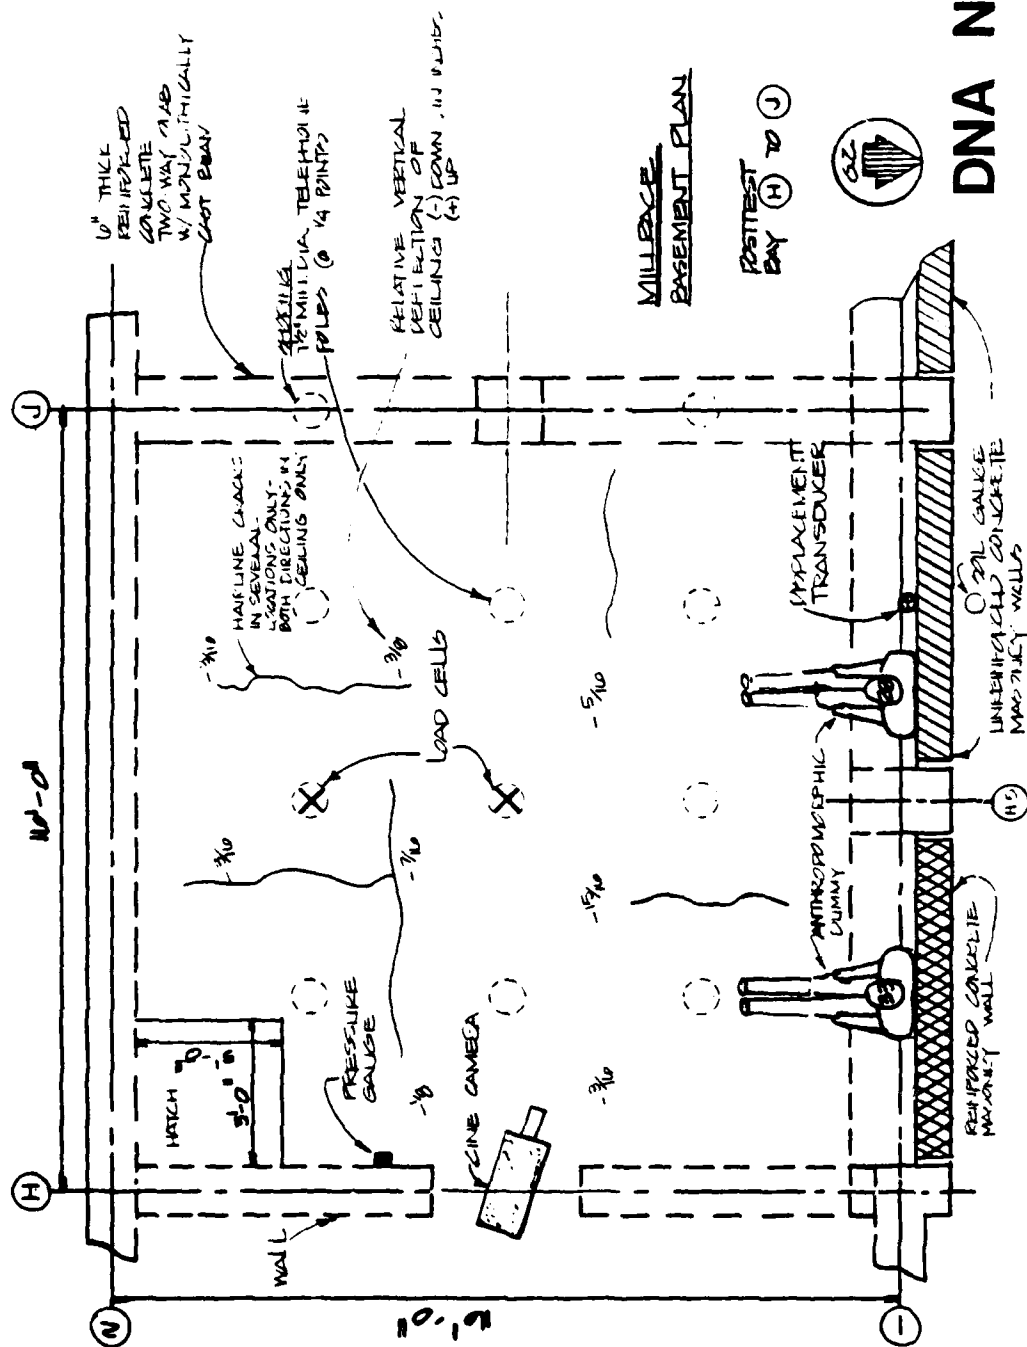
The pressure gauge located on the wall on line H, adjacent to the door in the bay from lines H to J (see Figure 5-48 for location), recorded a positive pressure of approximately 1.0 psi with a rise time of 125 ms, immediately followed by a rapid decrease to a negative pressure of approximately 2.5 psi in 150 ms.

Fig. 5-48. Location of Shoring, Instrumentation, and Damage to Two-Way Slab, Bay H to J, Area No. 4.

The load cell located nearest the wall on line 2 (see Figure 5-48 for location) in bay H to J recorded a loading of 180 kips and a loading duration of 50 ms, while the other load cell in the same bay recorded a loading of 205 kips with the same loading duration, 50 ms.

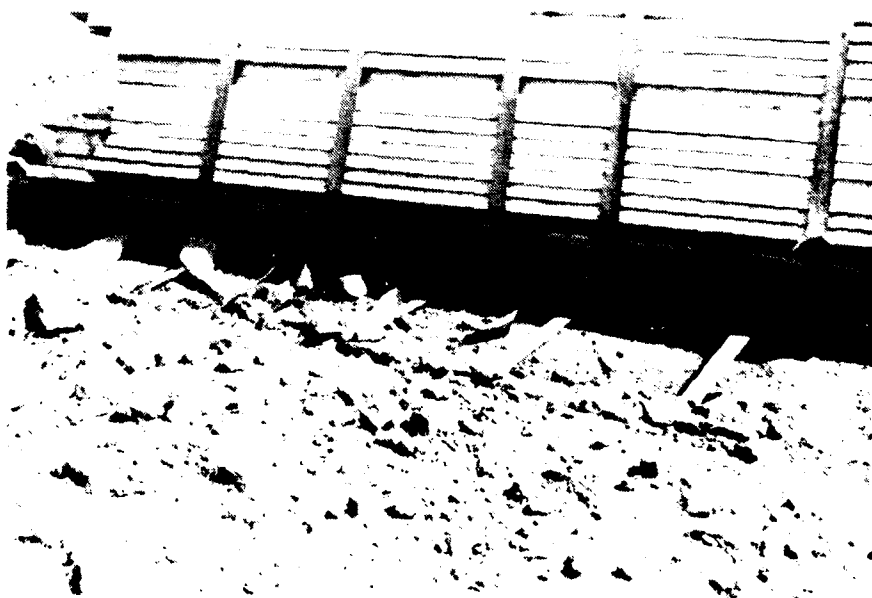
Fig. 7-40. Closeup Photograph of Lumber Stack Showing Cuts Caused by Webbing.
